DEPARTMENT OF ECOLOGY
INSPECTION REPORT

FACILITY: Duwamish Shipyard, Inc.
ADDRESS: 5658 W. Marginal Way S.W.
CITY: Seattle ZIP 98106 COUNTY: King PH. NO. 206-767-4880

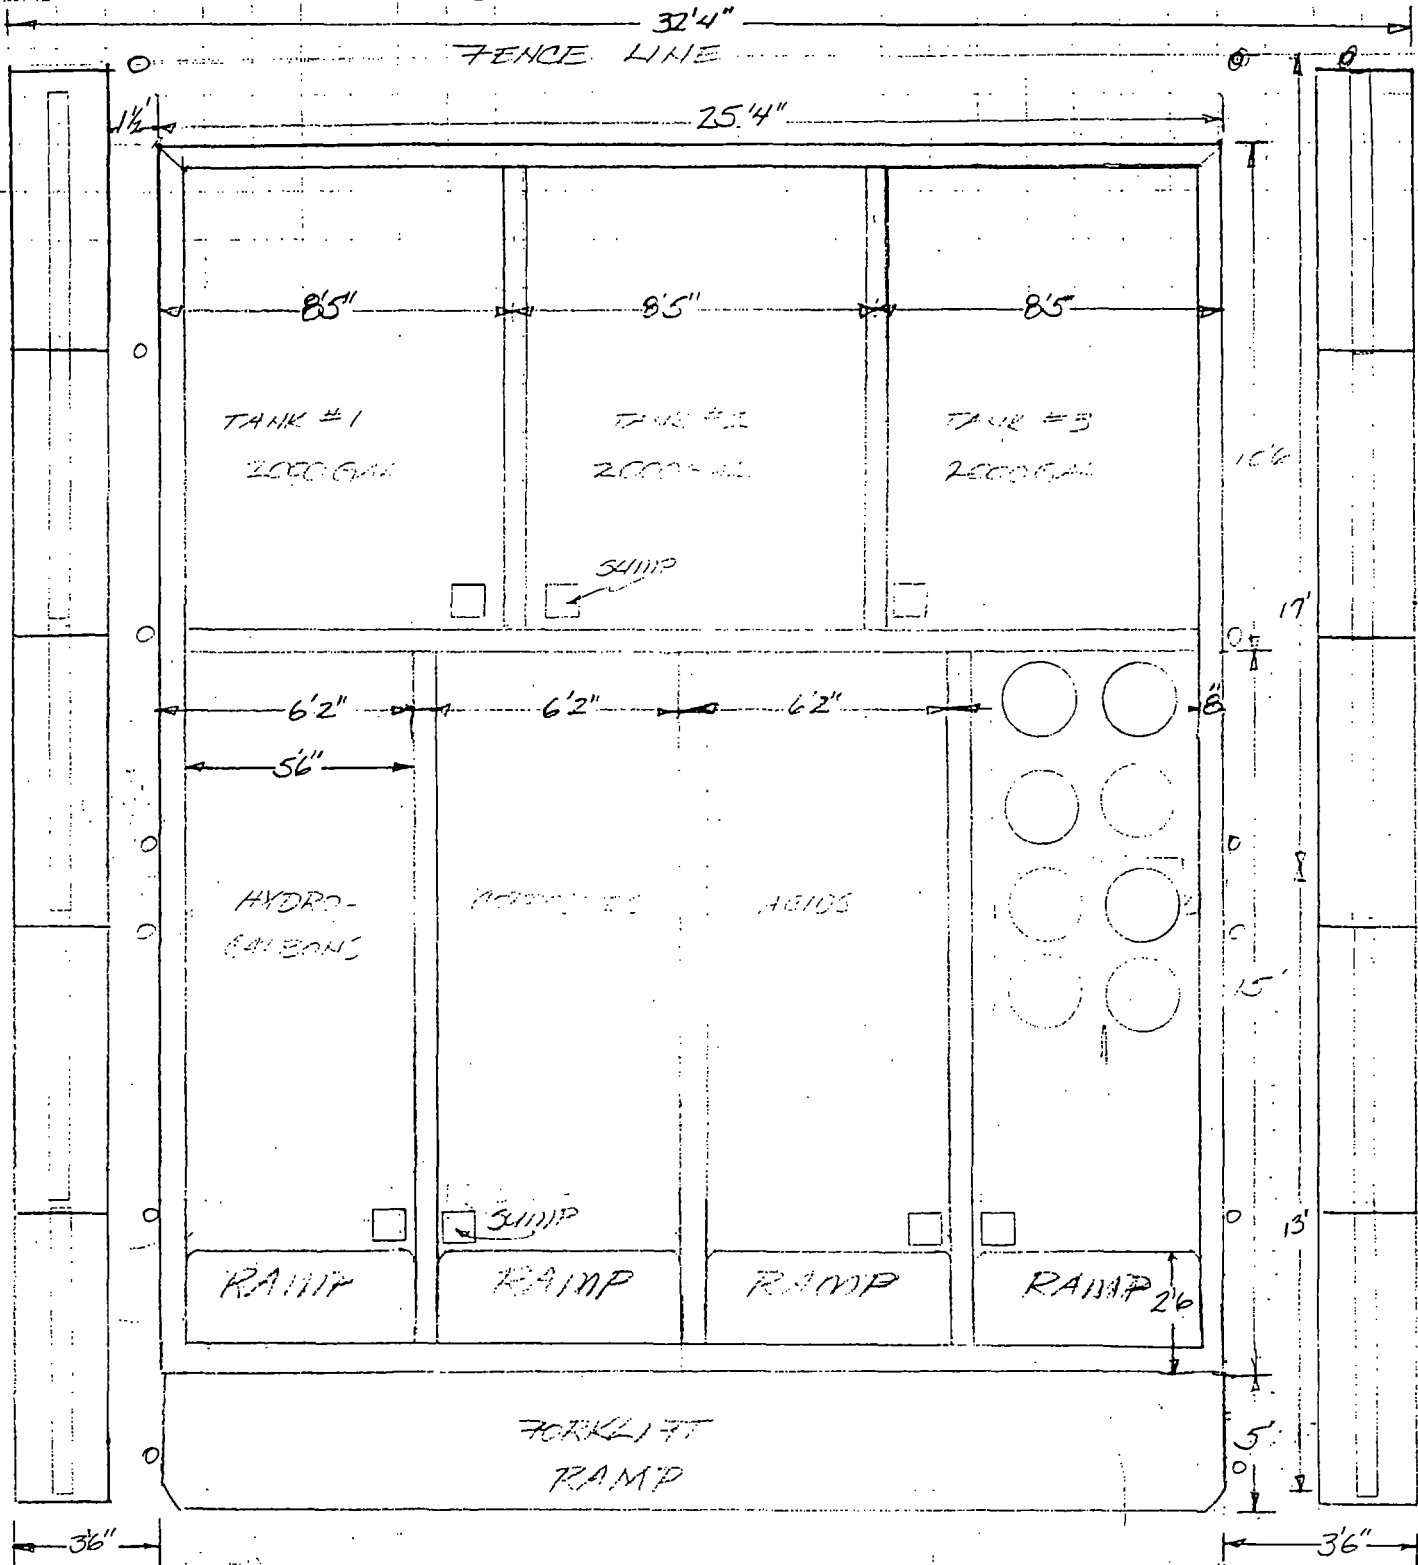
LIQUID CONTAINMENT AREA

will have corrugated steel roof

1 1/2" deep
